2014 EXECUTIVE REPORT-
EXTERIOR RENOVATION INVESTIGATIVE STUDY

EXTERIOR RENOVATION INVESTIGATIVE STUDY

MILWAUKEE COUNTY HISTORICAL SOCIETY

910 North Old World Third Street
Milwaukee, Wisconsin 53203

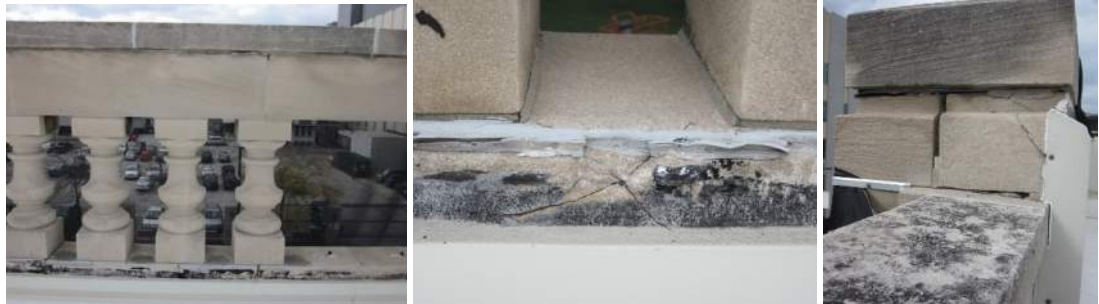
1. Balustrade

The limestone/brick masonry parapet deterioration evidences open and/or failed mortar joints, missing and cracked balusters, and deteriorated balustrade bases (plinth). The balustrade pier showed irreparable conditions provoked by water infiltration resulting in corroded mild steel strap anchors and degraded common brick, necessitating its total dismantling.

With the exception of the seven bays of solid balustrade, this study recommends a deconstruction of the balustrade down to the balustrade bases (plinth). Much of the balustrade assembly (cap stone, rail, baluster and plinth) remains sound and can be retained. The deconstruction is required to provide new alloy-coated copper flashing and stainless steel pins at all horizontal connections of the upper balustrade units.

This study identified missing and cracked balusters for replacement by newly fabricated limestone balusters. The Masonry Contractor will remove an existing baluster. The Stone Contractor will use the removed baluster as a template. The existing mild steel anchor pins will be cored-out at all balusters. Stainless steel pins shall be provided, with copper thimbles for flashing conditions. New alloy-coated copper flashing will safeguard the longevity of the limestone balusters. *(A001, A101)*

The solid masonry piers will be deconstructed and the limestone facing units, salvaged. All sixteen, individual piers shall have a new common brick core. The salvaged, cleaned limestone units will face this brick core. The pier's assembly shall be anchored by stainless steel masonry strap anchors.

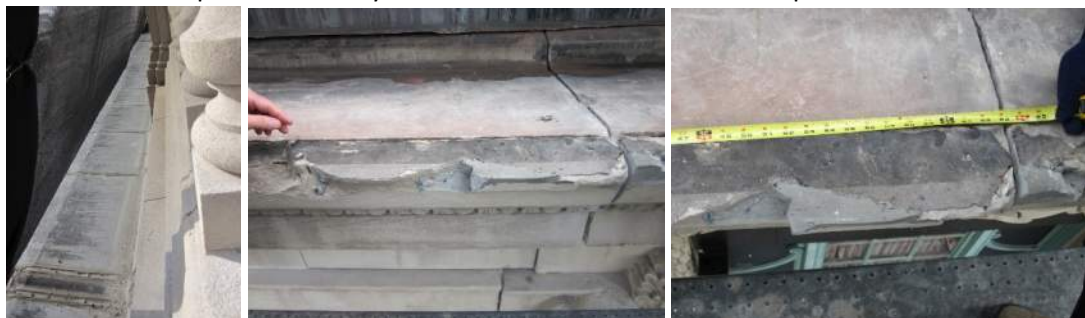
2. Cornice

The on-going deterioration of the projecting limestone cornice is primarily due to failed flat-seams and inadequate drainage of the copper gutter. A section of the gutter was cut away to assess the condition of the limestone unit. Previous power nailing to anchor the copper gutter had split the limestone cornice edge. A cementitious epoxy material, painted to match the adjacent stone, was employed to patch the fractured edge. In addition to these conditions of dangerous spalling, water was observed infiltrating the limestone entablature. This seepage behind the carved limestone units underneath the projecting cornice, weakens the brick back-up wall assembly and the embedded mild steel strap anchors.

The severely, spalled cornice edge can be repaired by removing the damaged edge. A new piece of stone will be keyed to the existing 7000 lb. limestone unit. This limestone Dutchman covers the entire cornice of the building perimeter. The new Indiana limestone will have a different patina. It will appear as an imperfect color match to its weathered receiver. *(A301, 3/A401)*

The existing flashed-in cornice conductor opening will be replaced by sidewall drains to assure efficient drainage. The carved limestone units, below the projecting cornice, will be cleaned of all efflorescence and accumulated dirt and grime.
(2/A401)

An alloy-coated copper gutter, flat seamed, will line the entire stone projection from the drip edge to the up-wall flashing. Expansion joints will be installed at the six drain locations. A watertight membrane and complete repointing of the cornice mortar joints will inhibit water infiltration into the wall assembly below. (1/A401)

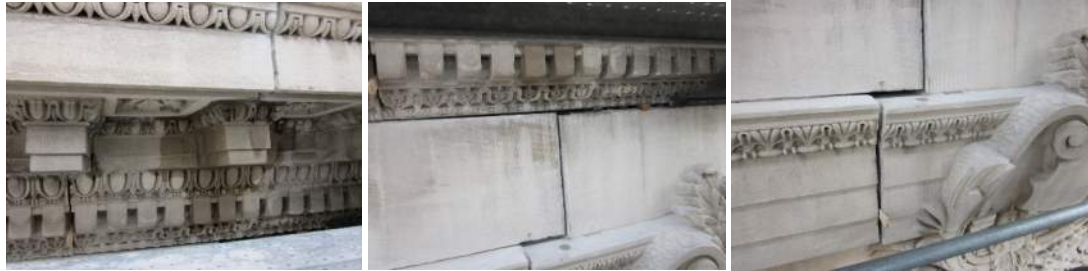
3. Cartouche

Seven carved cartouche/keystone units decorate the building at the top of the stone window arches. The cartouche in the northwest corner is seriously displaced and requires stabilization. The displacement is apparently provoked by a weakening of the wall assembly.

The re-alignment of the most displaced limestone cartouche will necessitate the complete deconstruction and rebuild of the wall's full-depth including the solid balustrade above. An assessment of the conditions necessitating the displacement will inform the subsequent stabilization of at least four of the remaining six cartouche assemblies. (Total of seven cartouche.) Alternatively, given that the assembly works as a true arch, a repair-in-place is feasible. Approximated life-span is 25 years. The visual displacement would remain.
(1/A301)

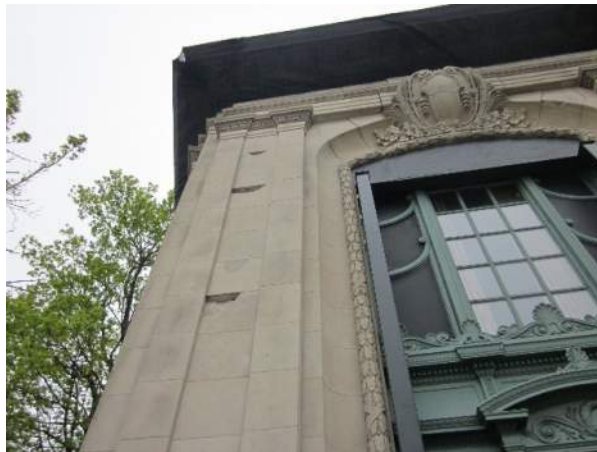
4. Façade Cladding

The cracking and spalling of limestone façade cladding typifies the oxide-jacking from embedded mild-steel masonry anchors. Some of these spalls were removed by Milwaukee County, exposing the corroding strap anchor.

Limestone repairs in the facades include: the spalled, cracked units; failed mortar joints. The attached photographic narratives and annotated architectural drawings illustrate the conditions and the scope of the restorative interventions.

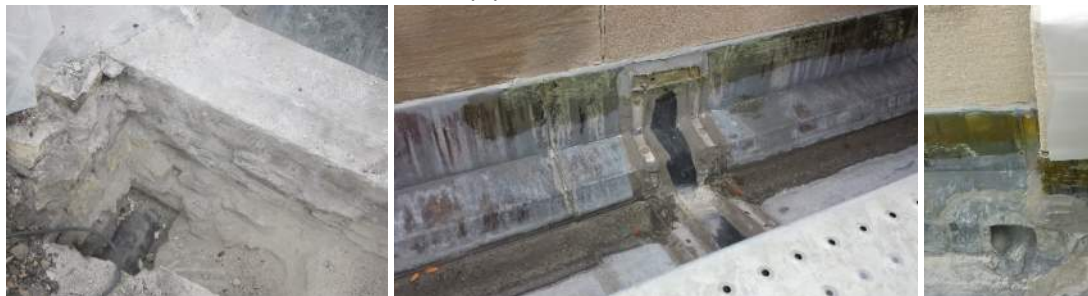
5. Plumbing/Roof Drains

The plumbing testing for the full length of the downpipes, starting from the cornice conductors and rooftop drains down to the basement, revealed no blockage or leakage. Likewise, no issues were found at the material transitions between the copper-sheathed cornice conductors and cast-iron downpipes.

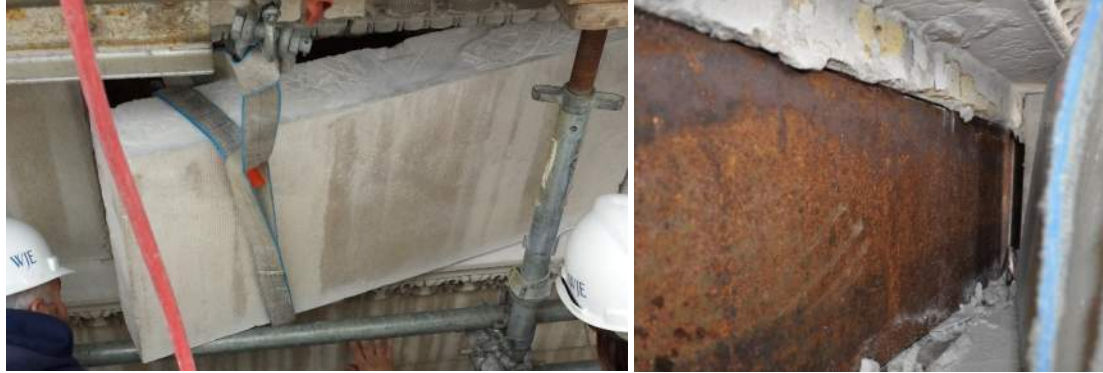
6. Structural Steel

During deconstruction of the southern-end balustrade, deeper investigation into a structural steel anchor rod revealed minimal corrosion with no diminished structural integrity. The “C” channel embedded in the entablature similarly was examined and found to have slight corrosion and no degradation. The masonry surround was dry.

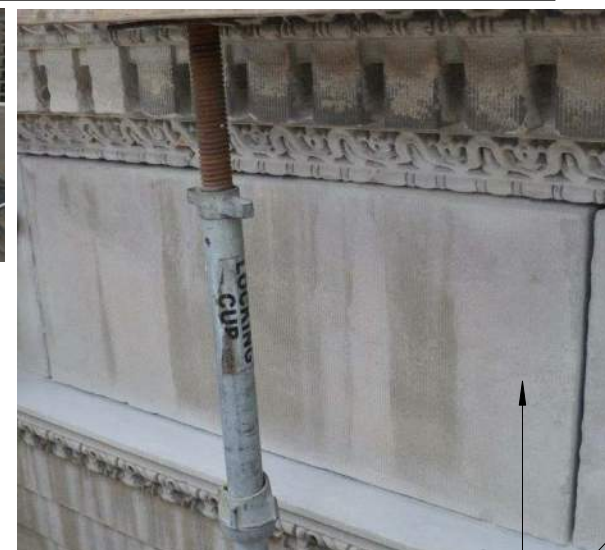
ROTATED FACADE STONE
OUTWARD TO VERIFY CONDITION
OF STRUCTURAL STEEL
CHANNELS, ANCHOR ROD.

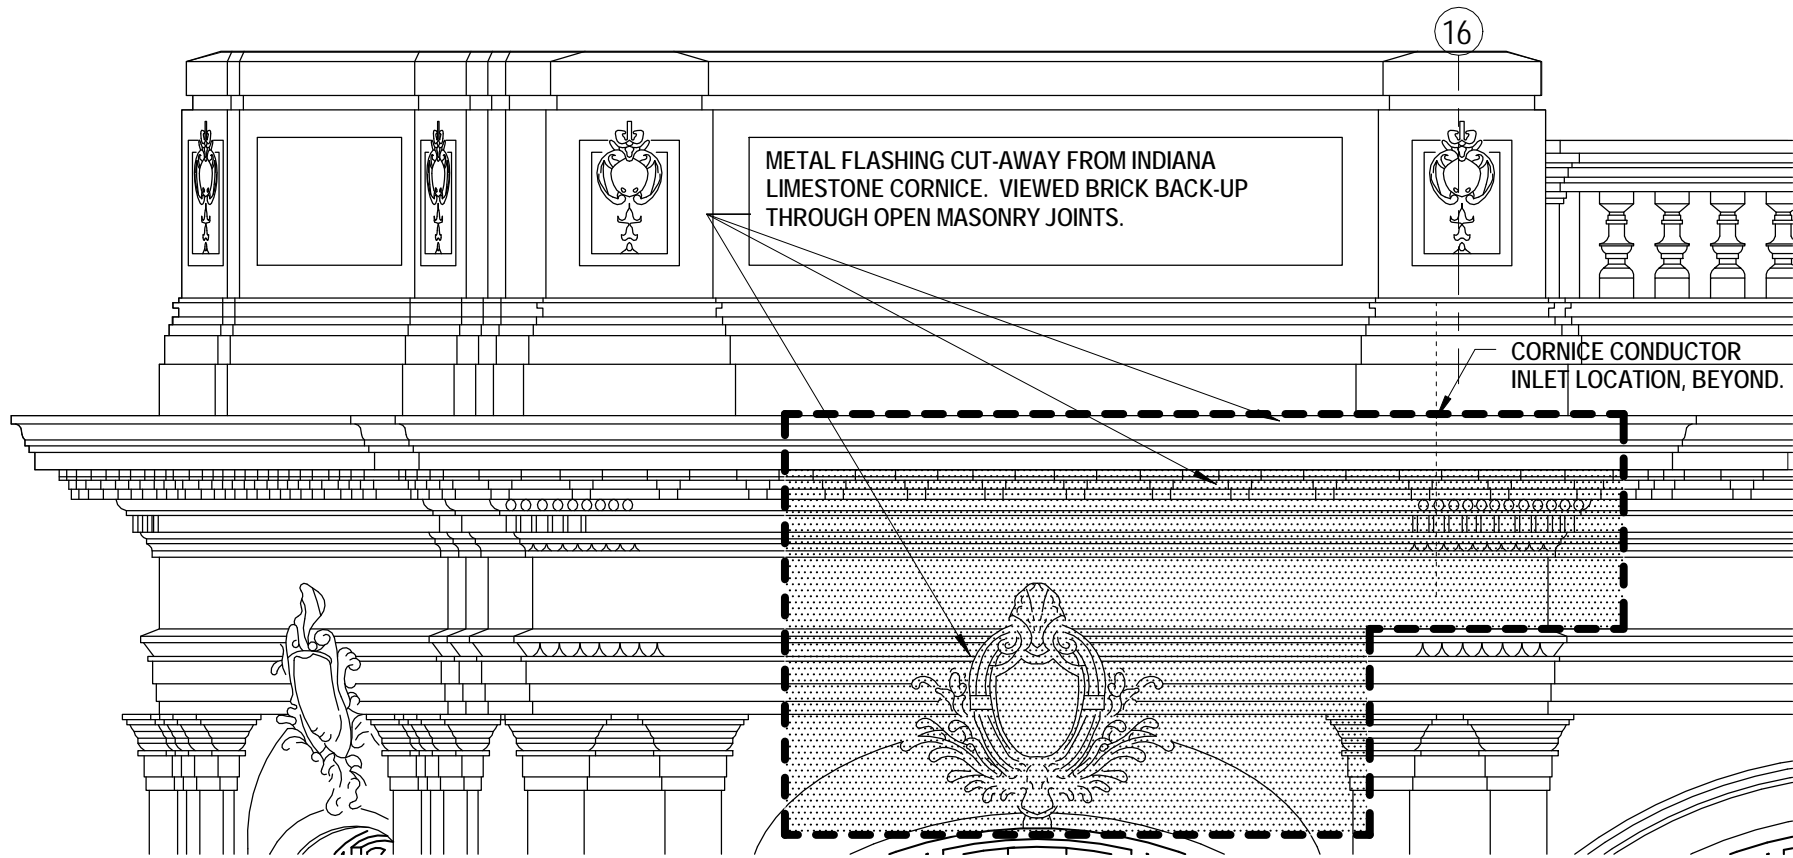
2 WEST ELEVATION - INVESTIGATION AREA
1/4" = 1'-0"

INDIANA LIMESTONE CLADDING PARTIALLY DECONSTRUCTED AT SOLID BALUSTRADE. BALUSTRADE PIER ASSEMBLY DECONSTRUCTED. FOUND CORRODED STRAP ANCHORS AND DEGRADED BRICK MASONRY CORE. TOP CAPS, RAILINGS, BALUSTERS, CARVED BASES, DECONSTRUCTED. MASONRY-ENCASED STRUCTURAL STEEL AND ANCHOR BOLT CONDITIONS VERIFIED.

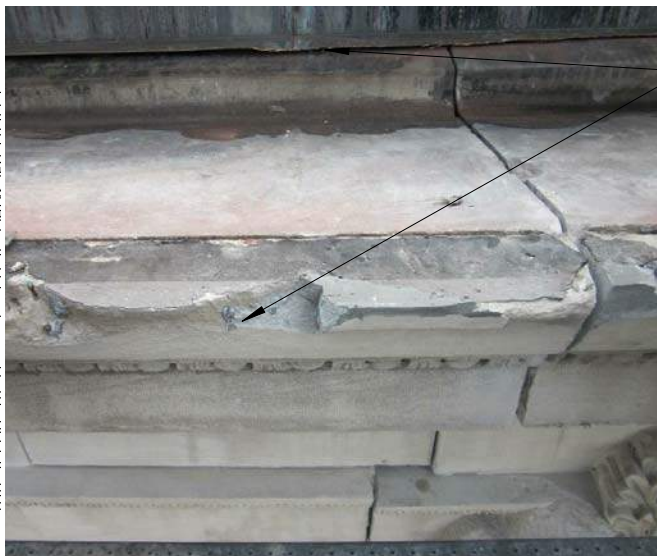
COPPER GUTTER REMOVED. REVEALED WET LIMESTONE CORNICE AND THE SEVERELY-SPALLED EDGE. PAST MAINTENANCE HAD PATCHED AND PAINTED THE CORNICE EDGE.

CONSTANT DRIPPING OF LONG-STANDING WATER IN CORNICE GUTTER. EVIDENCE OF SEEPAGE INTO LIMESTONE MASONRY WALL ASSEMBLY.

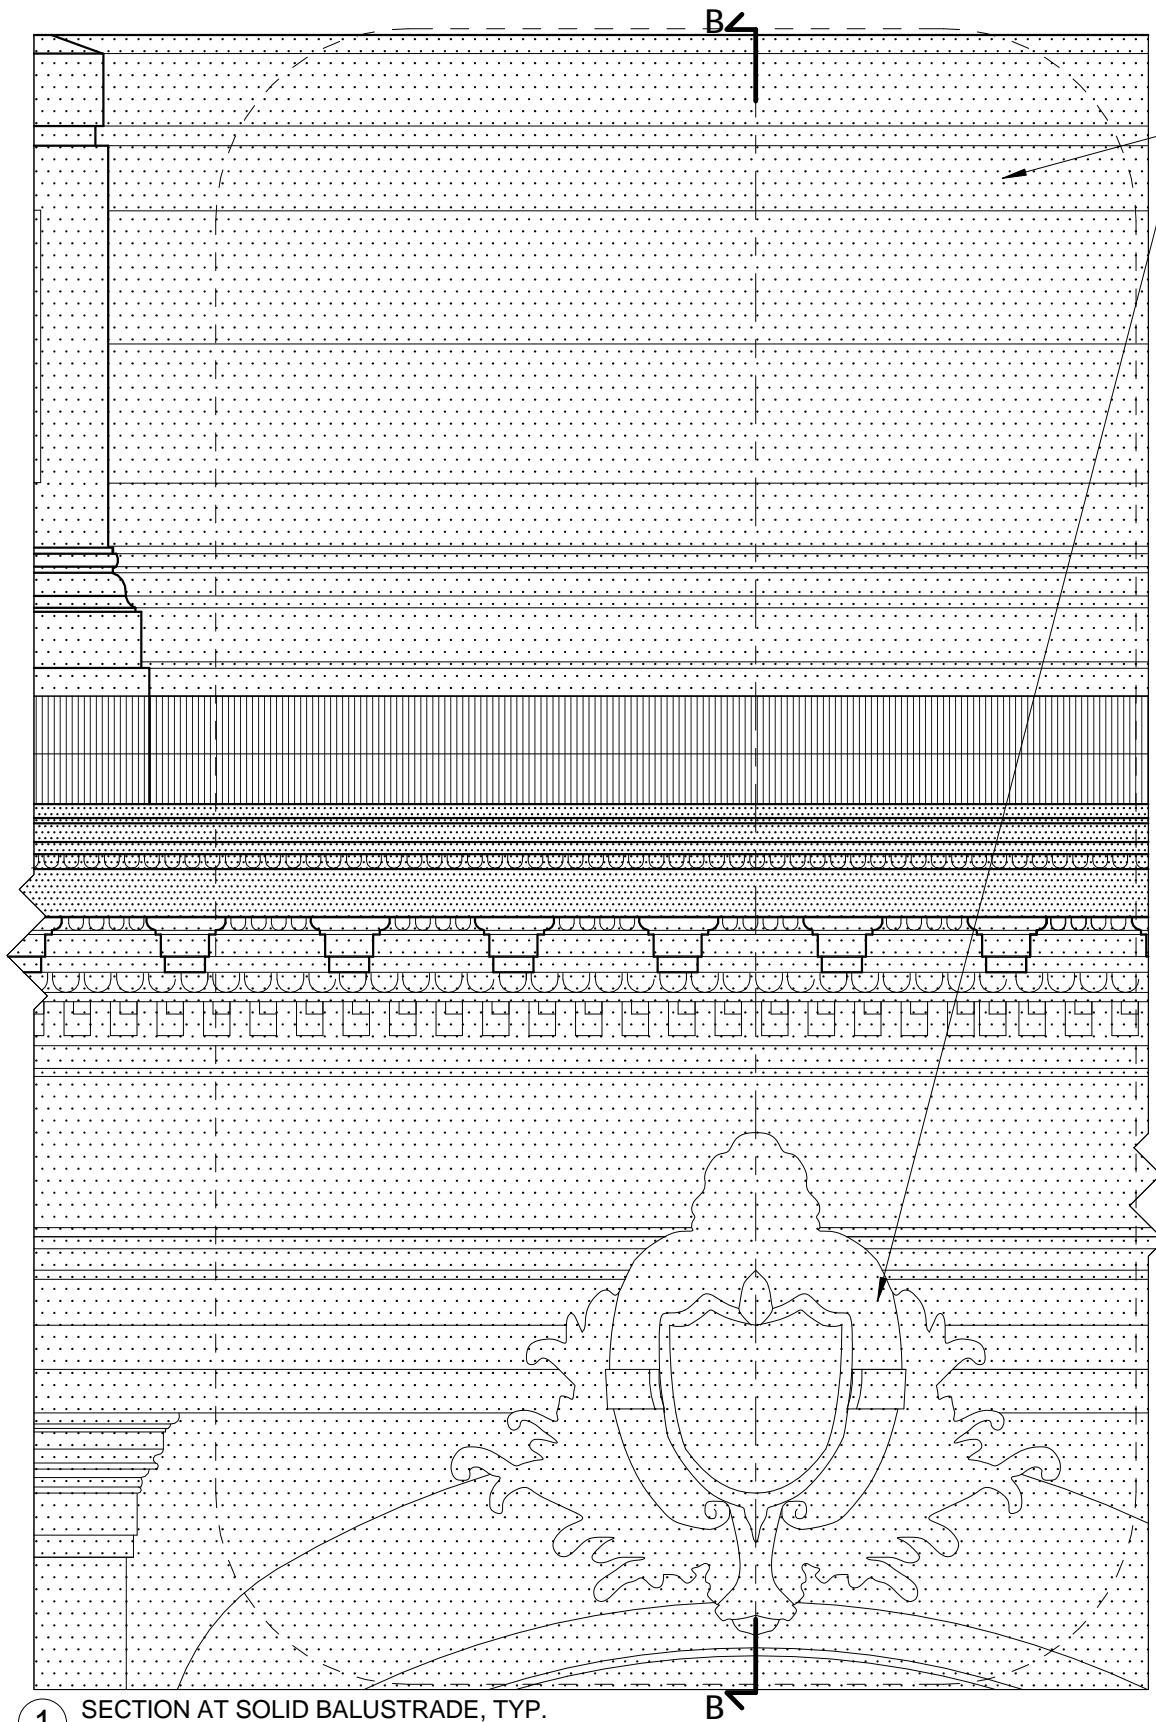
SECTION AT SOLID BALUSTRADE, TYP.

EXISTING LIMESTONE CORNICE EDGE CONDITION. WATER INFILTRATION AT COMMON BRICK BACK-UP WALL.

WORST-CASE CONDITION AT ONE OF SEVEN CARTOUCHE LOCATIONS. KEYSTONE UNITS SHIFTED DOWN AND OUT OF PLANAR ALIGNMENT.

AREA OF INTERVENTION FOR DECONSTRUCTION AND REBUILD OF SOLID BALUSTRADE, CORNICE, BRICK BACK-UP WALL, CARTOUCHE KEYSTONE UNITS. RE-ALIGN DISPLACED UNITS.

REMOVE, REPLACE CONTINUOUS METAL FLASHING AT TOP CAPS, TYP. NEW SS PINS WITH SEALANT/MASTIC. REPOINT ALL DETERIORATED MORTAR JOINTS.

STANDARD METAL PANEL TO REMAIN. VERIFY AIR CIRCULATION.

CARVED LIMESTONE UNITS TO BE CLEANED OF EFFLORESCENCE AND DIRT AND GRIME, TYP.
